TECHNICAL INSTRUCTIONS

SPECIAL SERVICE CAMPAIGN 70F (SAFETY RECALL)

2007 AND EARLY 2008 MODEL YEAR TOYOTA CAMRY ALL WEATHER FLOOR MAT

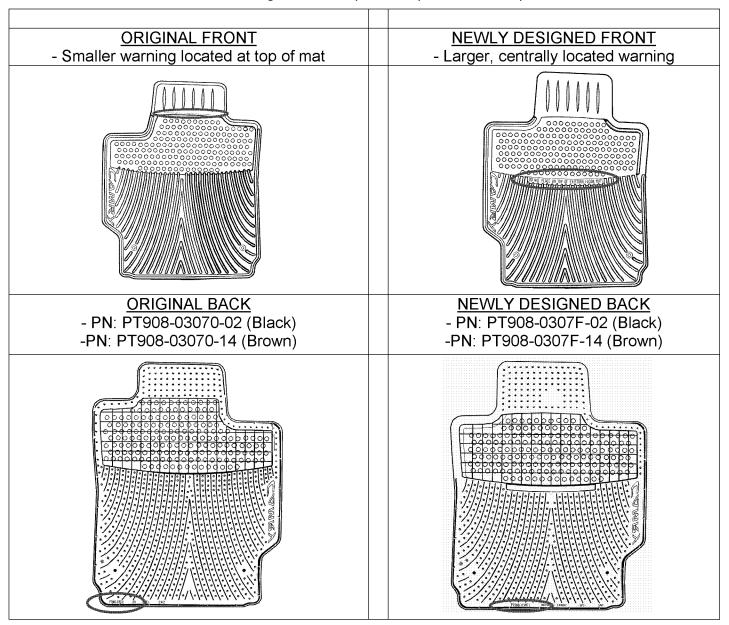
Confirm if the *original* driver side All Weather Floor Mat (see the diagram below for key areas to aid in identification of the original vs. the newly designed mat) is present in the vehicle.

- If the original mat is NOT present, no action is necessary.
- If the original mat IS present, proceed to step B.

B. REPLACE THE AFFECTED DRIVER SIDE ALL WEATHER FLOOR MAT WITH THE NEWLY DESIGNED ONE

IMPORTANT: MAKE SURE THE RETAINING HOOKS (CLIPS) ARE PROPERLY INSTALLED AND SECURED TO THE VEHICLES CARPET AND THE ALL WEATHER FLOOR MAT.
